**Subject: Inspection of Fire Damage at Franklin Simon Store
Northland Shopping Center**

Date of Inspection: March 3, 1975

RALPH J. STEPHENSON, P.E.
CONSULTING ENGINEER

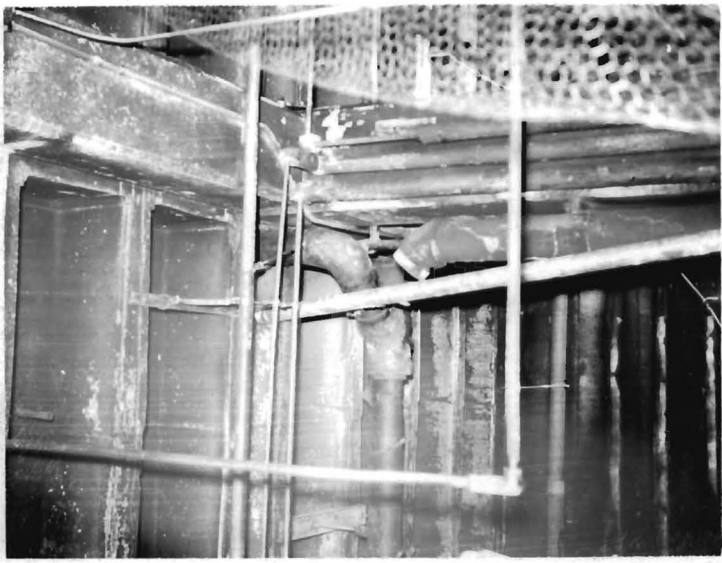
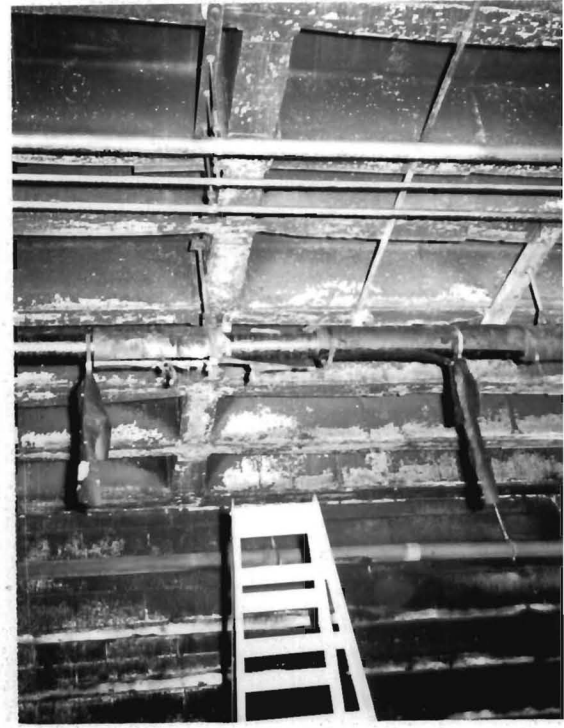
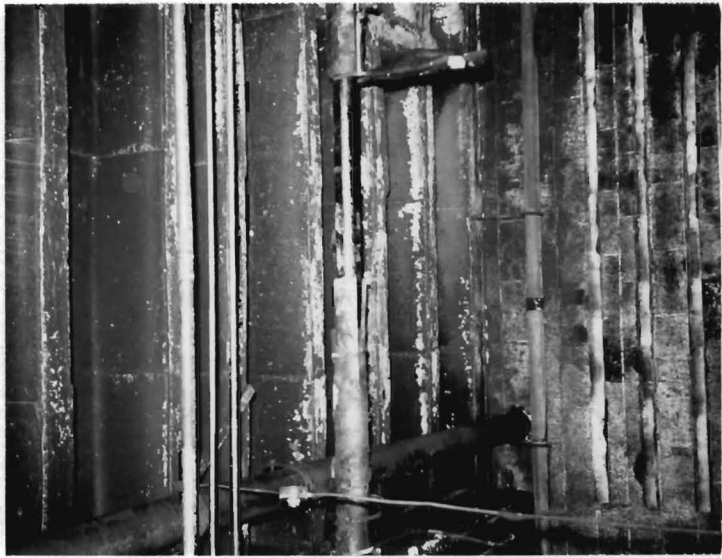
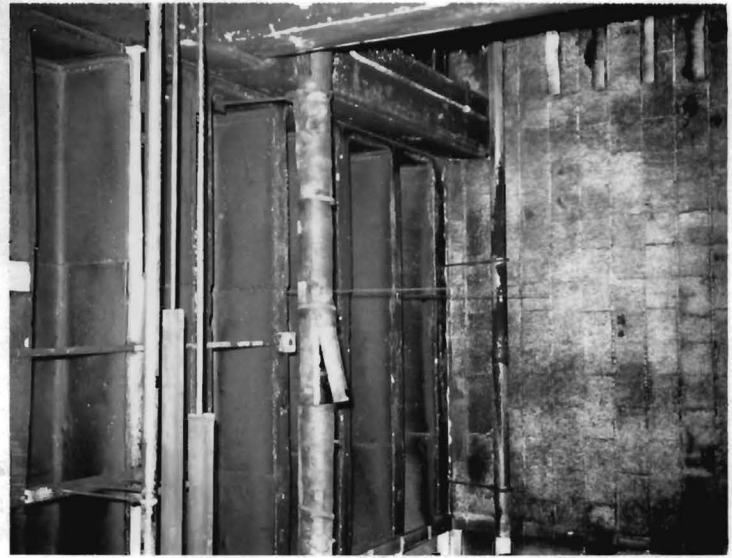
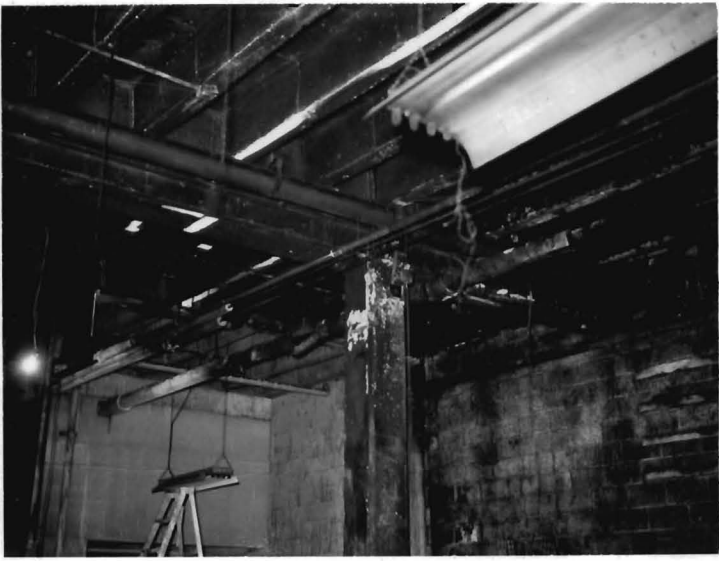
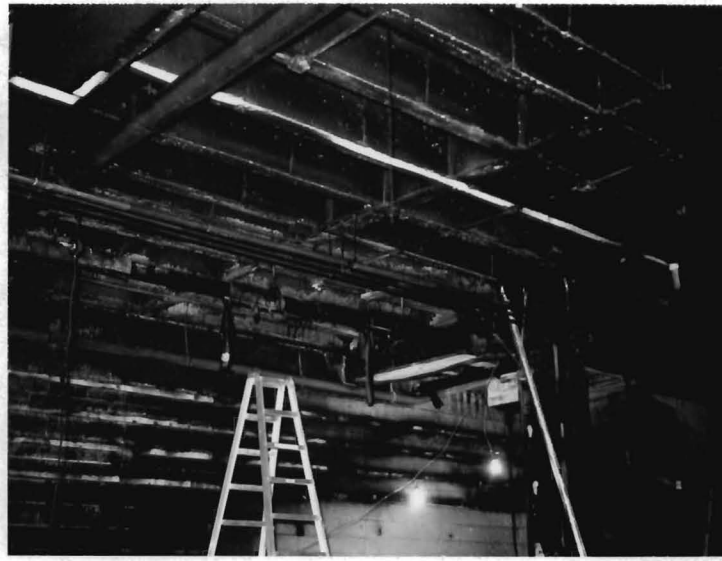
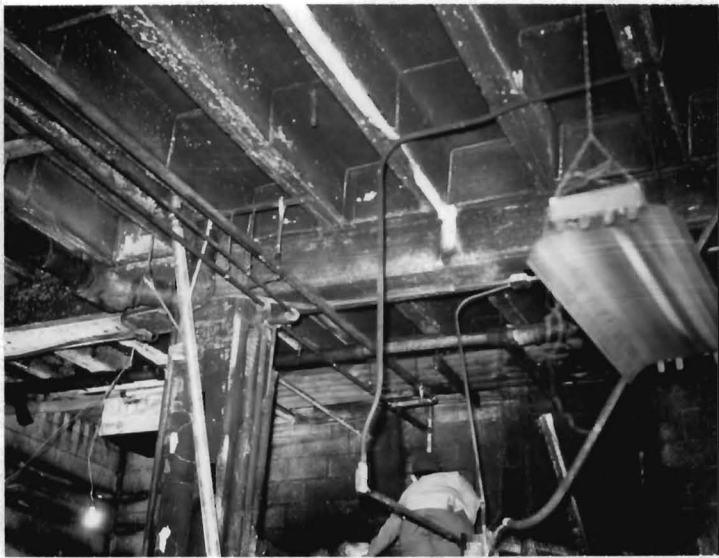
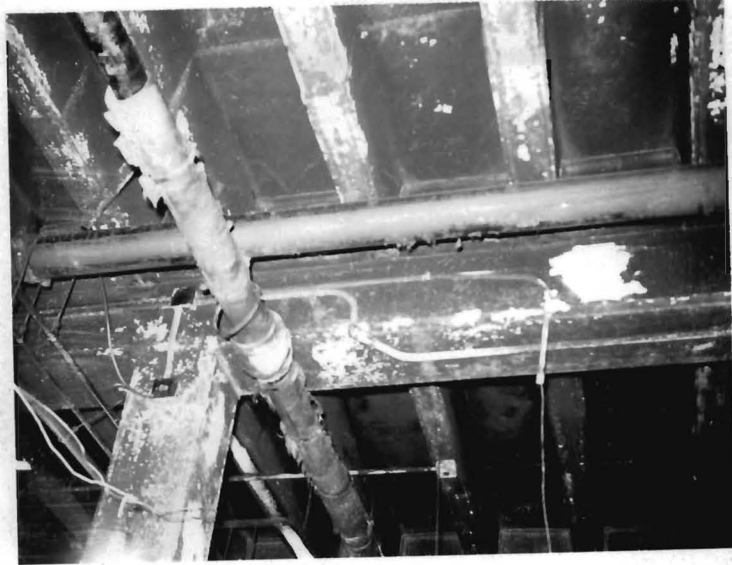
Overall, it appears that no major structural damage has been done, and that the structural integrity of the frame is maintained. There was some miscellaneous loose concrete found on edges of one or two of the joists and a short section of loose concrete was found on the side of the beam spanning from column 127 - 56 to 127 - 57. However, in each case the loose concrete when chipped away revealed sound concrete underneath. I recommended to Mr. Thweatt that as the area is renovated and refinished that the process include scraping and removal of miscellaneous loose concrete where such concrete was found outside the reinforcing steel. If any miscellaneous chipping reveals outside edges of

I took eight Polaroid photos of the major affected area and these will be kept in the project file for reference.

re-steel, they should be patched with a bonding grout to again provide the reinforcing steel with fire protective covering. If, in the renovation process, any major chipping is encountered which causes removal of concrete from any part of the reinforcing steel except the outer face, I suggest that we re-inspect the member to determine if the structural capacity has been affected. In my brief inspection it did not appear that there were any of these areas in the section inspected.
