# Facility Condition Assessment Update

May 2018

**FERRIS STATE UNIVERSITY**

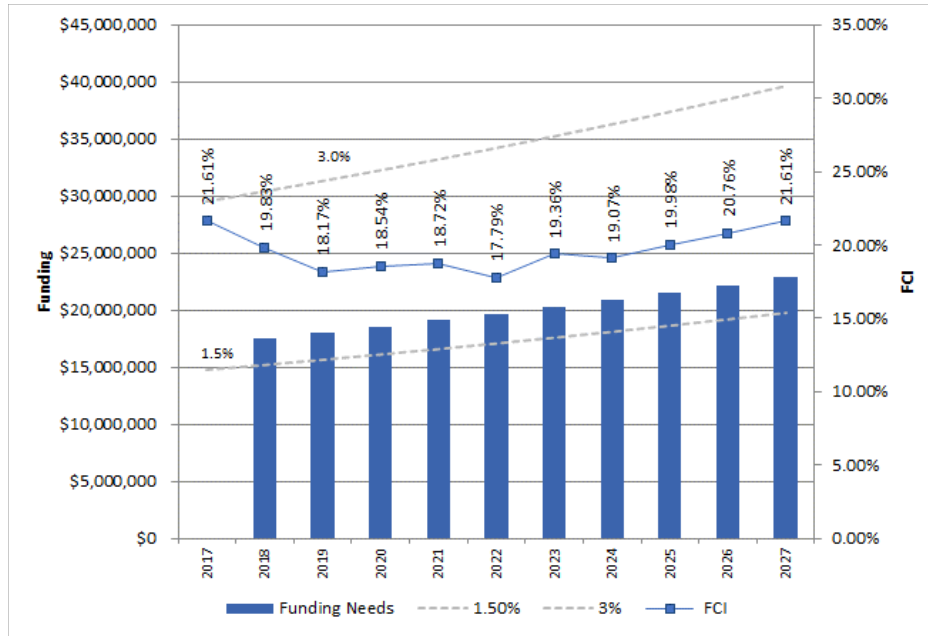
Figure 4 - Invest to Maintain Current FCI of 21.61% (Big Rapids, only)

Invest at a rate sufficient to match the total Current Period (2018-2019) and Forecast Period (2020-2027) annual funding needs, thereby maintaining the current FCI of 21.61%. The capital reinvestment in this scenario amounts to \$200,691,283, which is nearly 50% of the needs estimate for the period 2018-2027. In this scenario, the proposed annual investment is intended only to keep pace with forecast future funding requirements resulting in the FCI beginning and ending the period at the same value. In this scenario, the proposed annual investment exceeds the sustainable funding range.

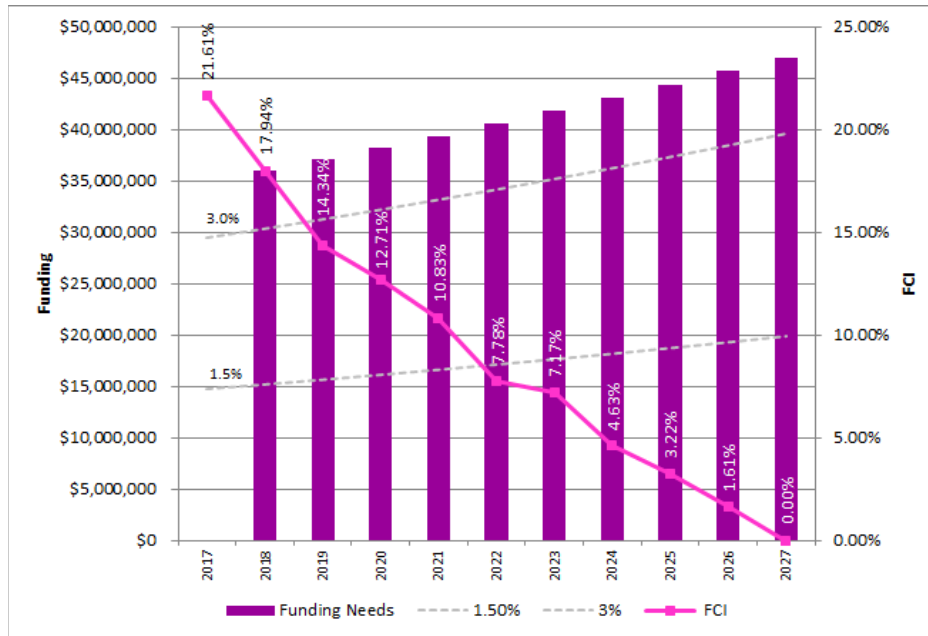
Figure 6 - Improve FCI to 0% (Big Rapids, only)

Increase funding to offset the recurring system renewal costs plus fully pay down existing deferred maintenance to improve the FSU facilities’ condition from an FCI of 21.61% to an FCI of 0%, a level considered to be excellent (like new) condition. The solid line tracks the annual FCI over the funding cycle. The capital reinvestment in this scenario amounts to \$413,210,974, or 100% of the needs estimate for the period 2018-2027. In this scenario, the proposed annual investment exceeds the sustainable funding range.

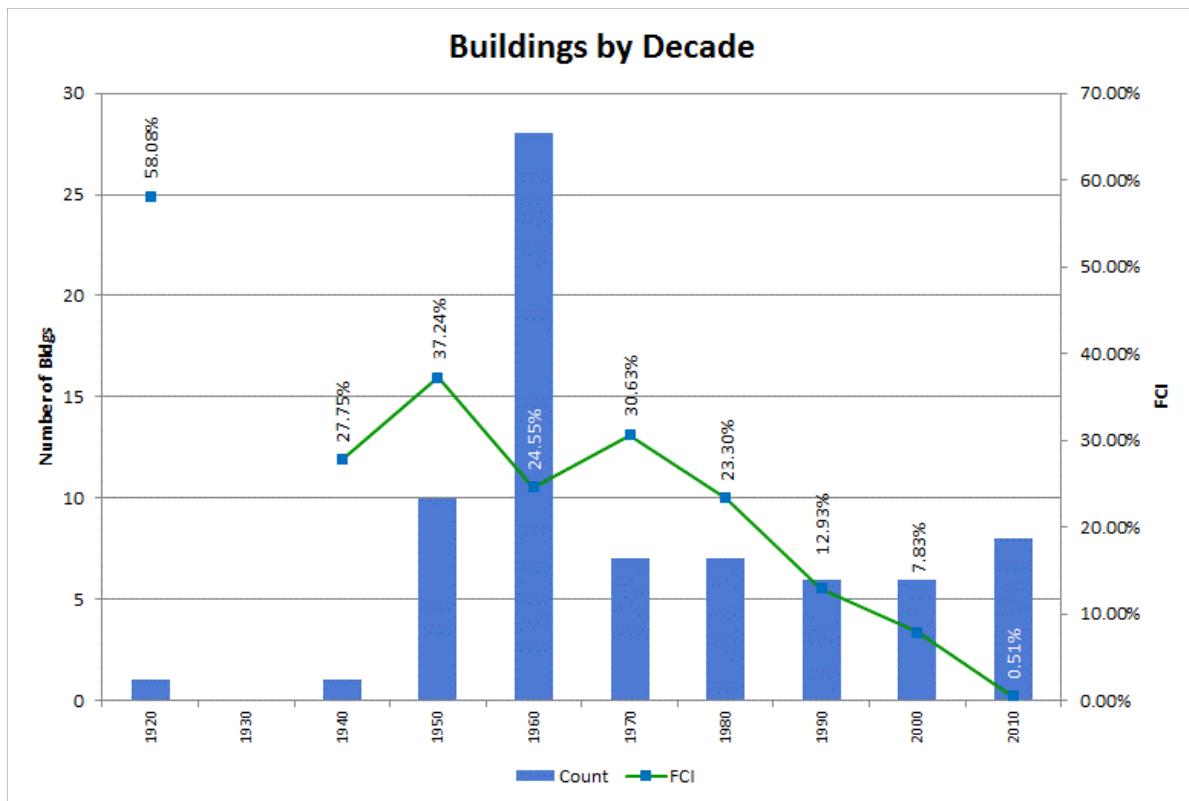
Figure 7 - Buildings by Decade (Big Rapids, only)

The following chart illustrates the number of facilities built per decade and the calculated FCI per decade for all Big Rapids & Grand Rapids campus buildings.

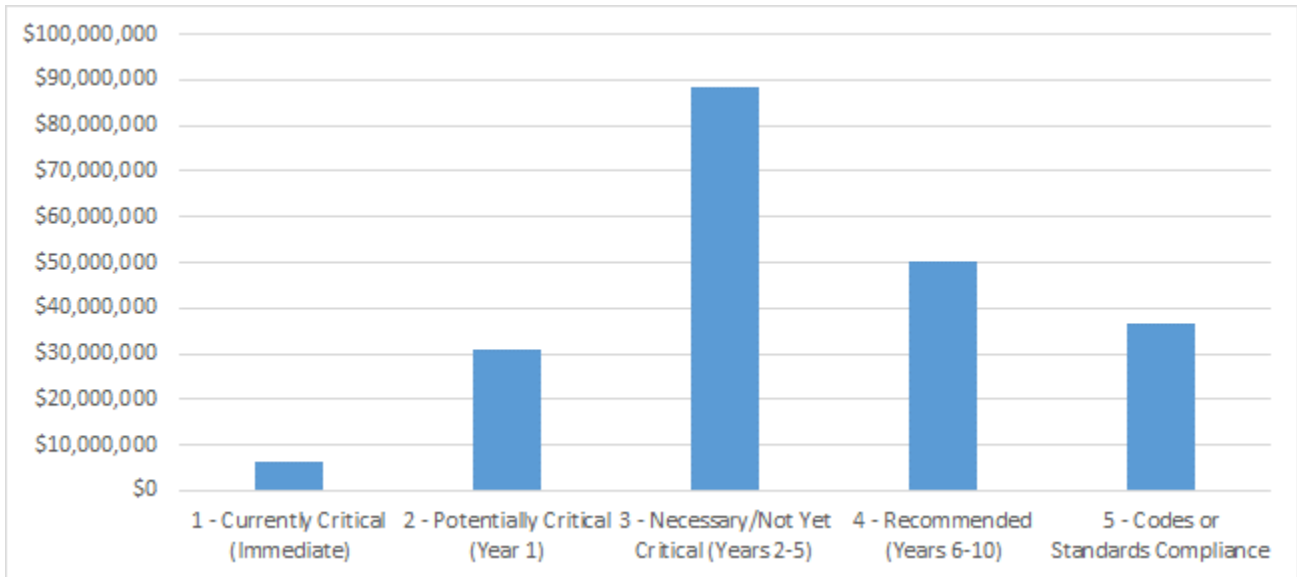
Figure 10 - Facility Condition Needs by Priority (Big Rapids, only)

The following chart indicates facility condition needs by Priority found in the assessment. Priority was determined by assessor and University staff observations. Priorities do not reflect the *affordability* of needed repairs, nor do they reconcile facility needs with a University's master plan priorities or academic program objectives. Refer to the Appendix on page 24 for more detailed descriptions of the priorities.
