Ferris State University
Facility Condition Assessment Report
2010 Limited Scope Update

April 25, 2011

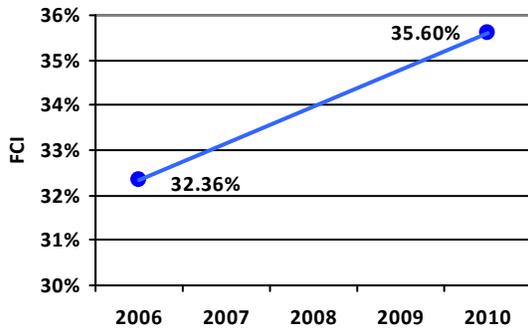
The chart at the left demonstrates the change in FCI expressed in 2006 dollars. Note that when the FCI is adjusted for escalation as a result of the RS Means update, we see the effective change was an increase of a little over 3% during the period.

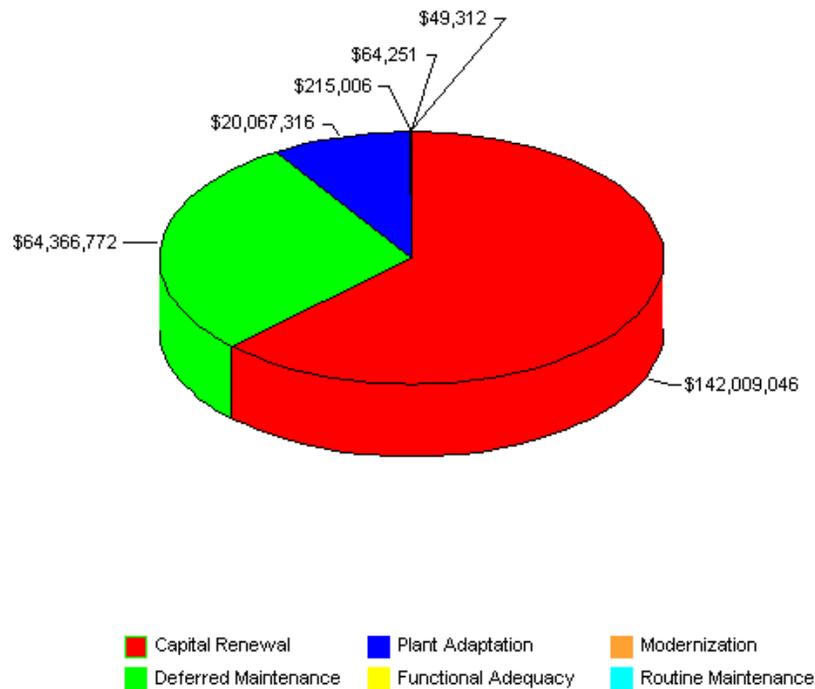
Deficiencies by Category

The deficiency costs identified in the assessment are grouped in to Capital Renewal, Deferred Maintenance, Modernization, Plant Adaptation and Routine Maintenance categories (see Definitions for more information). The data presented in the chart (below) provides a summary of all deficiencies with a breakdown by their respective Category.

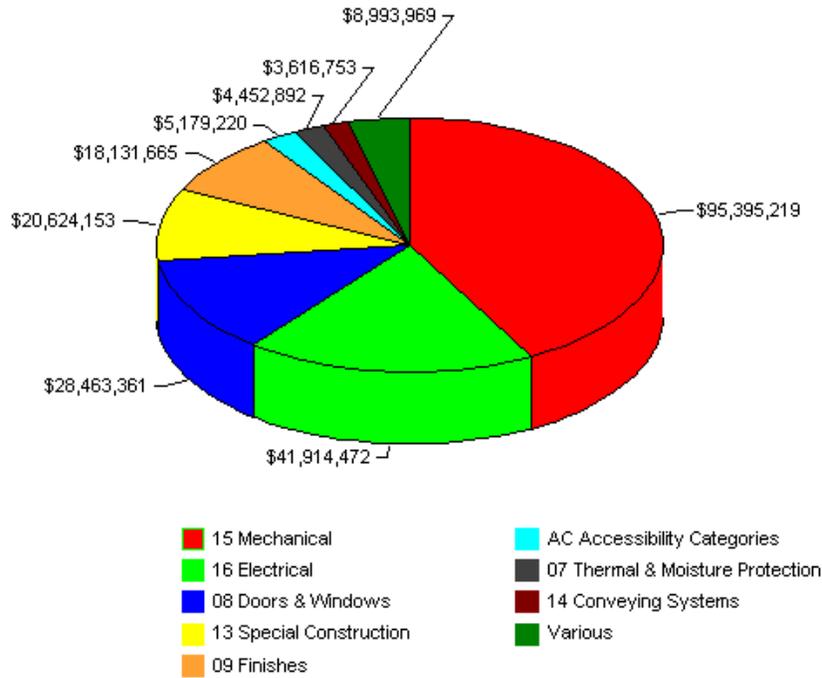
Results by Facility System

The following chart gives a breakdown of the recorded deficiencies by their respective systems for the assessment. The individual systems appear in clockwise order from greatest to least need for repair starting at 12 o'clock. The legend at the right provides a key to the color coding used in the graphic.

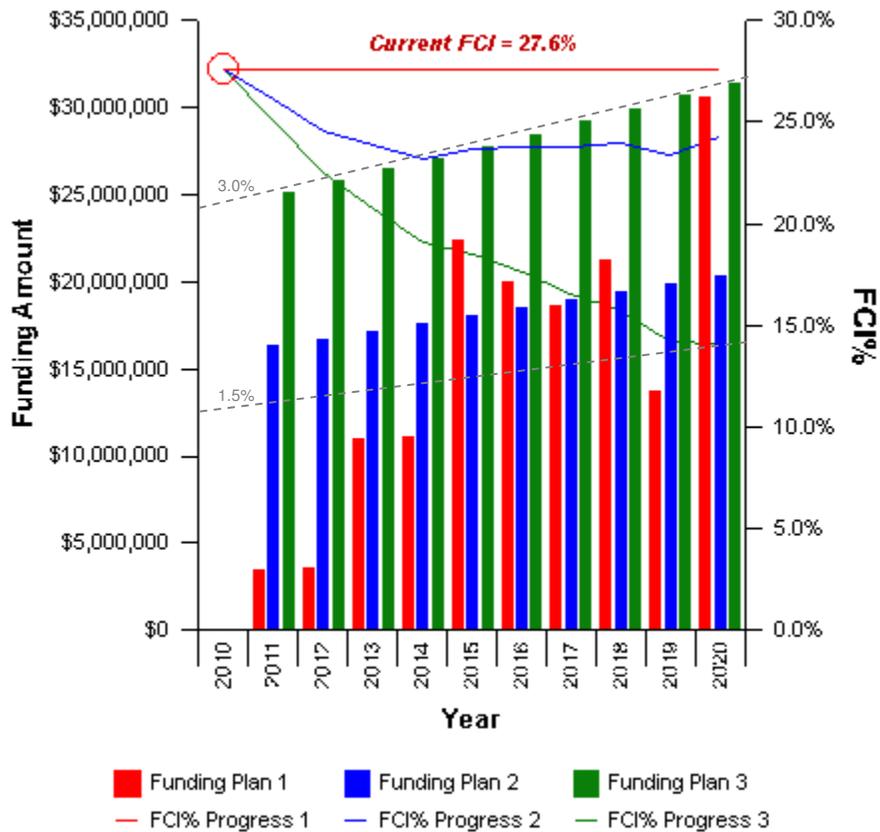
Funding Requirements – 10 Year Renewal Projection

The chart below combines the funding needed for repairs with the predicted capital renewal requirements. The annual funding requirements (bars) are read from the left axis and FCI% (lines) from the right axis.

The chart illustrates the 10-year total funding requirements for the Ferris State University facilities for the following three (3) funding scenarios:

The blue line and associated funding bars applies a premium to buy-down the current deficiencies to achieve an FCI of 25% in addition to the capital budget dollars spent for capital renewal.

The green line and associated funding bars applies a premium to buy-down the current deficiencies to achieve an FCI of 15% in addition to the capital budget dollars spent for capital renewal.

The blue bars in the chart clearly indicate that an annual funding level of nearly \$20,000,000 is required to achieve the goal of reducing the current FCI to 25%, which is within the rule of thumb target range. However, the green bars in the chart predict that an annual funding level of almost \$30,000,000 would be required to reduce the FCI further to 15%. Further, there are significant

spikes in required funding levels in 2015 and again in 2020 that indicate funding for deferred maintenance and capital renewal should be increased in anticipation. These indicators, taken together, may compel the University to consider options for replacing the facilities with FCI > 60%. Removing facilities from the portfolio can have a dramatic effect on your overall FCI and future funding requirements.

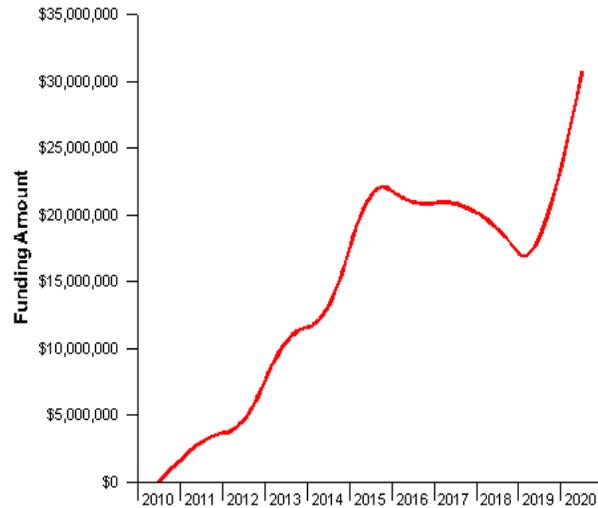
10 Year Capital Renewal Forecast

systems. The 10-year Capital Renewal Forecast chart (below) illustrates the projected funding requirements, excluding current deficiencies for each facility. The data supporting this chart can also be found on the Capital Renewal Forecast report for each facility included in the Comet Reports section.
